REQUEST FOR USER INSPECTION: DMM HARNESSES

8th July 2016

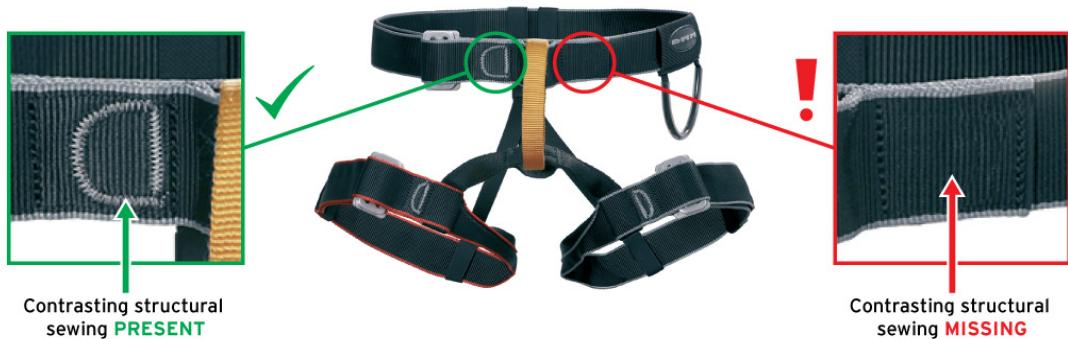
Following the discovery of missing structural sewing on a DMM Brenin Harness during a routine inspection by an end user, we are issuing the following information to users of all DMM harnesses, and asking them to carry out a visual inspection on the key structural sewing on their harnesses.

- If your harness is missing the structural sewing, stop using the harness, quarantine, and contact DMM directly as per the instructions on the Harness Inspection Sheets.
